Sustainable Bridge Structures

Edited by Khaled M. Mahmoud

Khaled M. Mahmoud

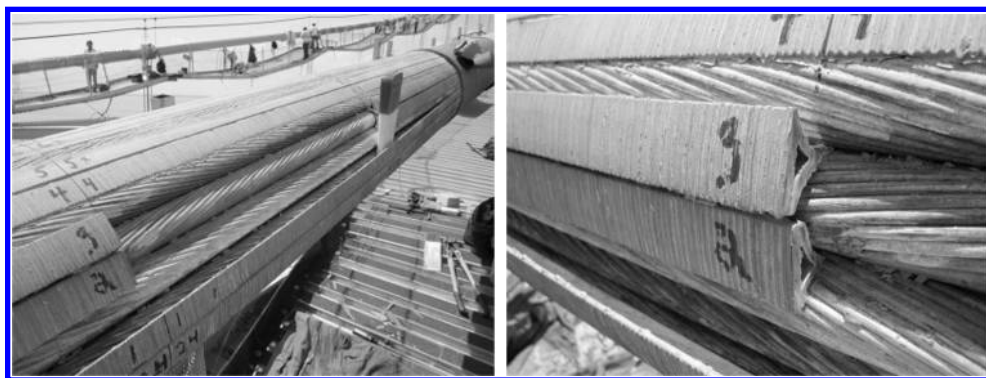
Figure 2. Helical strand cable (left); aluminum fillers between exterior strands (right).

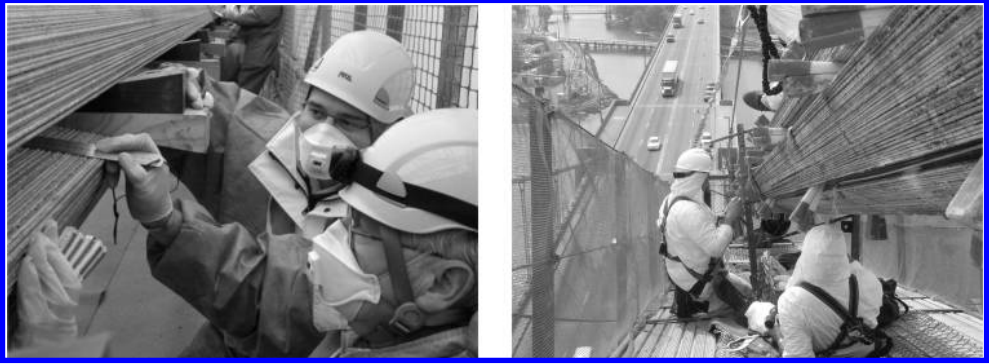
Figure 6. Internal cable investigation.

The interval for internal cable investigations is based on the findings from the first internal cable investigation, which is recommended to occur at approximately 30 years from when the bridge was built, or sooner depending on the findings from the hands-on biennial inspection of the cable exterior. Based on the age of the bridge and the level of corrosion in the wires, subsequent internal investigations may vary from 5- to 30-year intervals, with more frequent investigations occurring as the age of the bridge and level of deterioration in the wires increases.

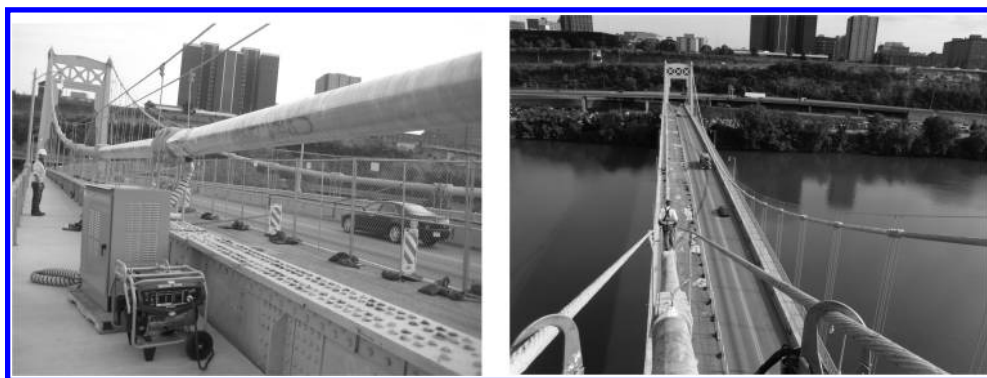
Figure 14. Flow trials on Philip Murray Bridge – temporary blower installed at mid main-span (left); view of main cable (right).

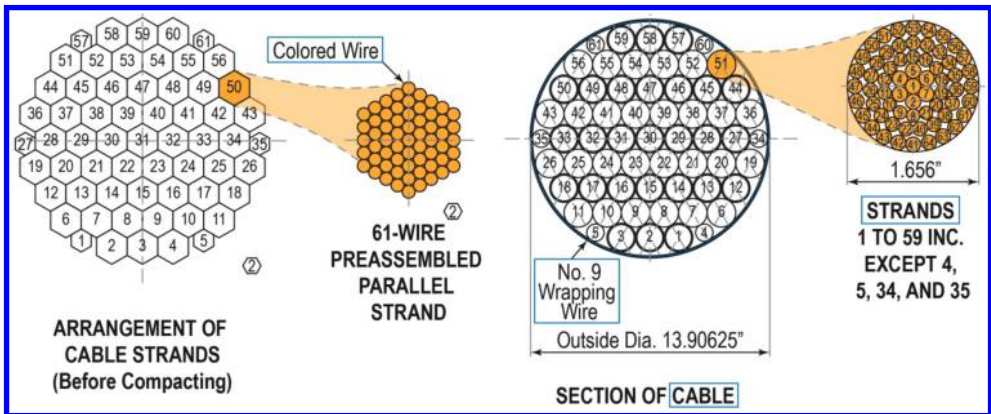
Figure 2. Parallel wire strands (left) and helical wire strands (right).

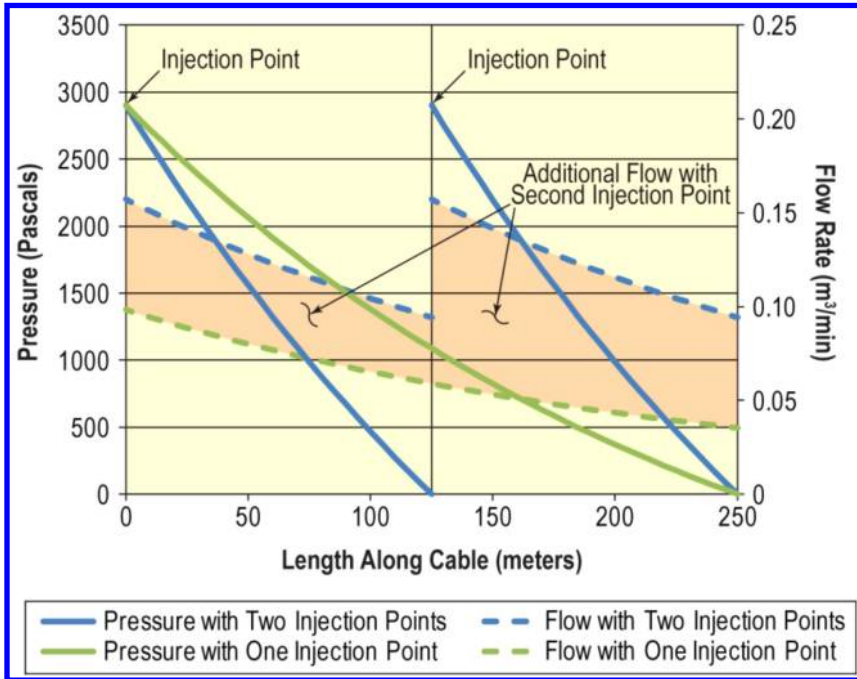
Figure 7. Comparison of total flow with two injection points vs. one injection point along the same cable length.

As illustrated in Figure 7, for very long flow lengths or cables resistant to flow, the flow will simply reduce to the level consistent with the installed pressure drop. The highlighted area is the increase in total flow that is gained by dividing the flow length into two parts. In this case the flow is doubled using two injection sleeves. The importance of total flow is that it determines the cable dry-out period.

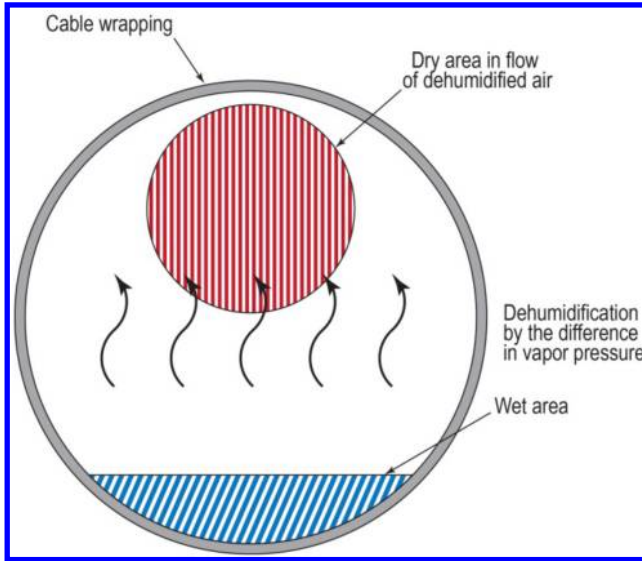
Figure 8. Dehumidification by the difference in vapor pressure within a cable section.

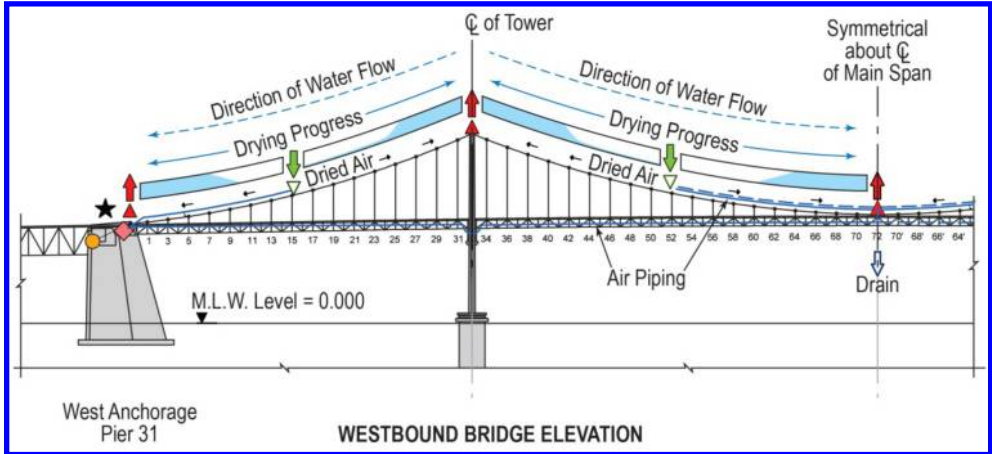
Figure 9. The drying process.

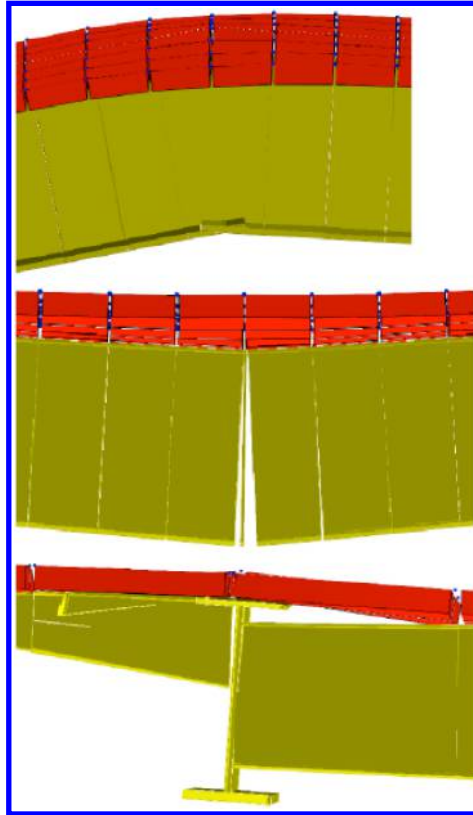
Figure 9. Modeled steel members fracturing in negative bending (top), positive bending (middle), and shear (bottom).

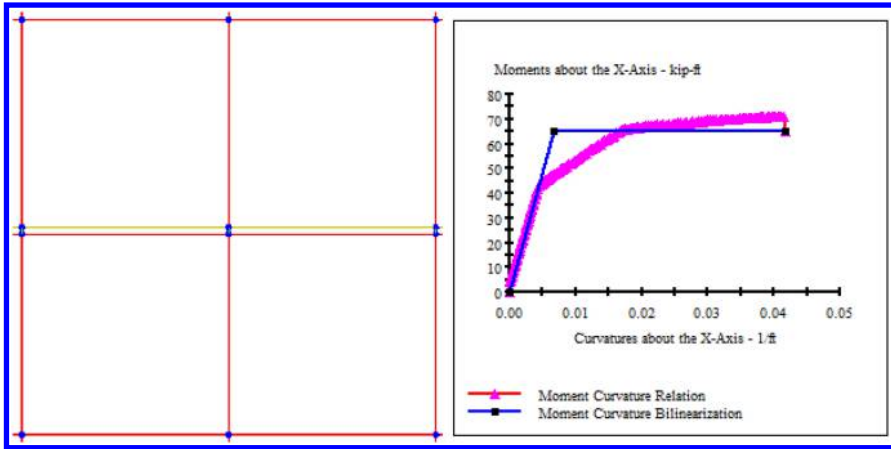
Figure 13. Detail of the model showing the small gap between plate elements (left) and an example of the non-linear spring properties (right).

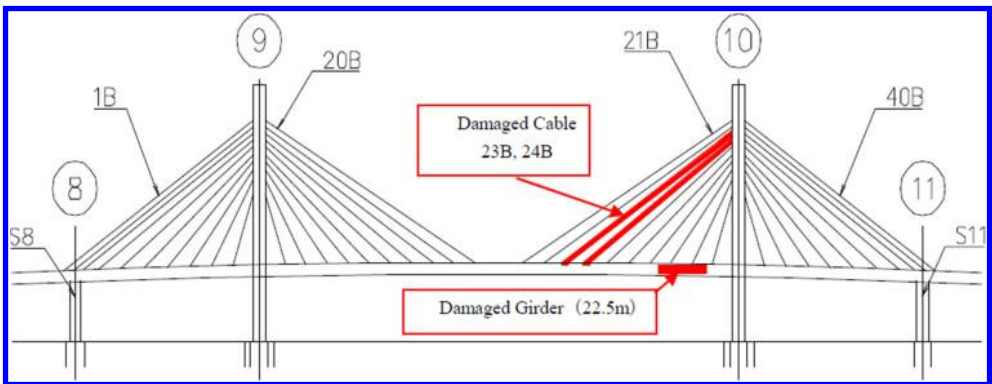
Figure 3. Damaged location on bridge.

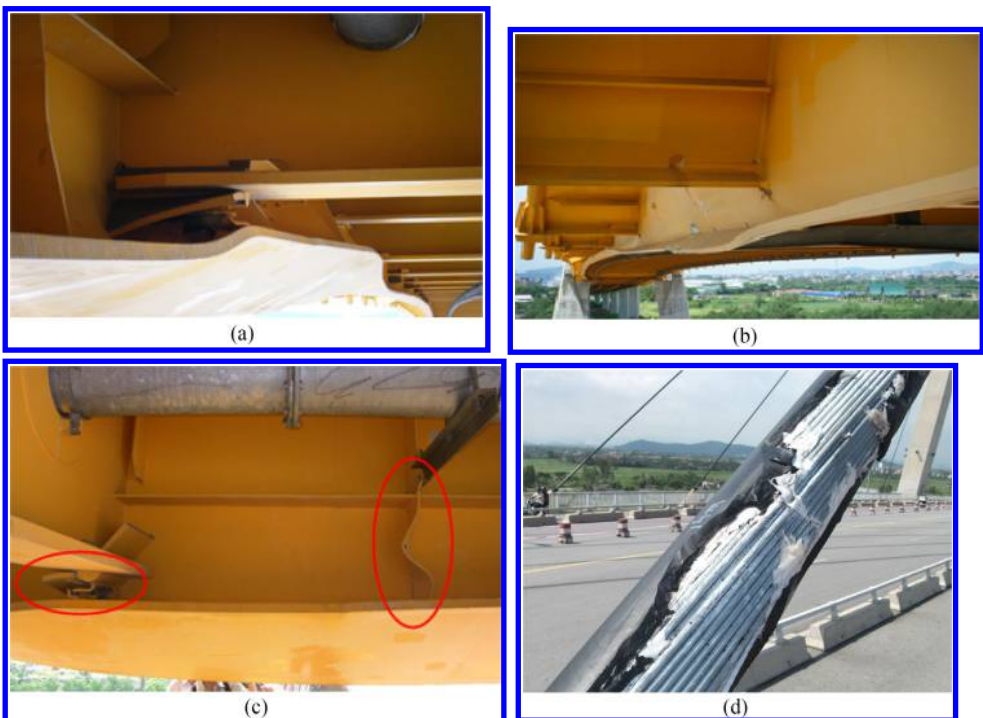
Figure 5. a) Damaged edge girder (Inner side), b) Damaged edge girder (Outer side), c) Buckled stiffeners and d) Cable Damage.

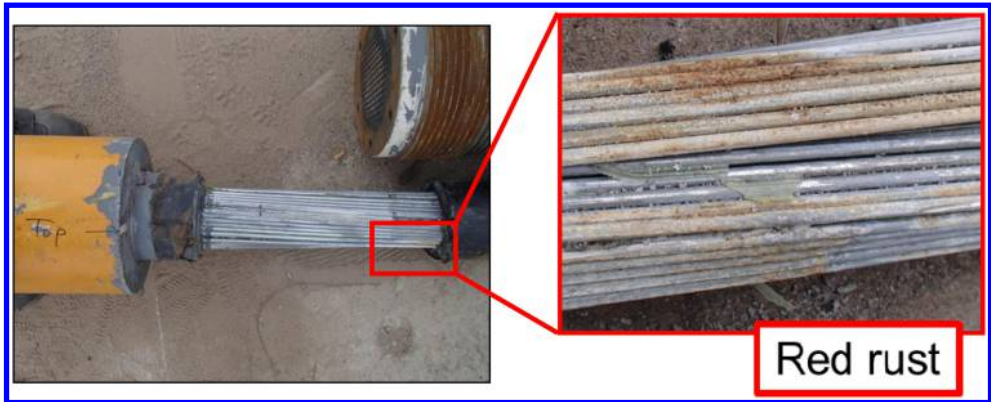
Figure 8. Opening investigation result of damaged stay cable.

Since the scratches on the surfaces of the element wires were small, it was presumed that the static strength of the wires had not been degraded. The fatigue strength of the wires, however, varies depending on the shape of the scratches, and even a scratch as long as 100 mm may cause strength degradation. Accordingly, the fatigue strength of damaged element wires should be regarded as degraded. However, it was presumed that only the element wires on the outermost layer of the steel wire bundles were scratched and that the element wires in the inner layers were sound. Therefore,

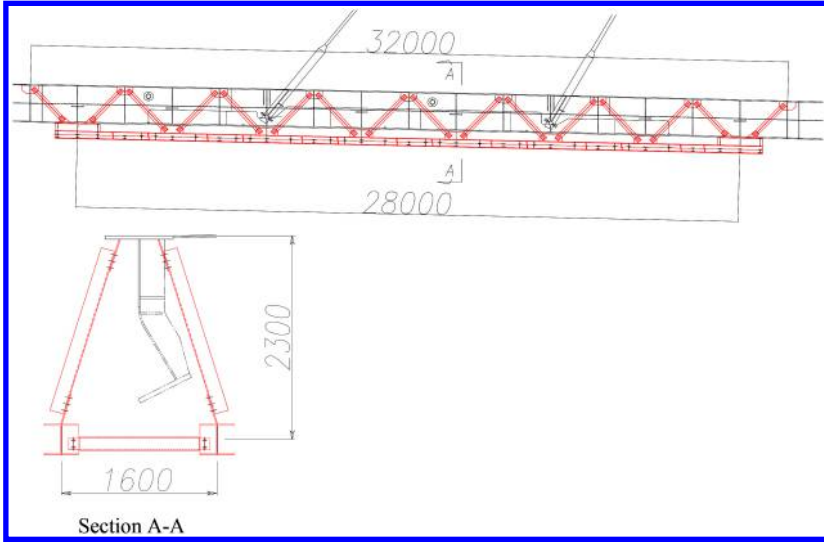
Figure 10. Temporary Bypass Truss (DWG).

In order to partially cut the edge girder and remove the cut portion to replace it with a new member, it was necessary to first attach reinforcements for supporting the section force. A large crane was not able to be placed immediately above the damaged portion, so we were only able to place a hydraulic crane with a lifting capacity of 1000 kN. Moreover, in order to perform the repair work, we needed to pass the boom of the crane through the space between existing stay cables. It would be impossible to transfer very large members through the space. Since we could only use limited equipment to reinforce the bridge and with limited space, we determined to perform the reinforcement work by using a truss structure (Temporary Bypass Truss). Figure 10 illustrates the structure of the truss.

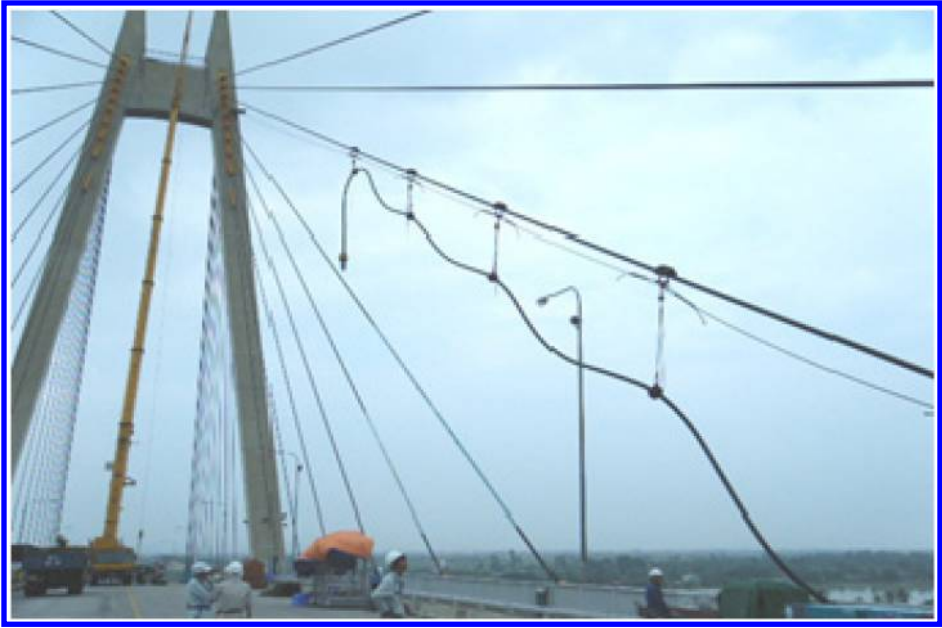
Figure 16. Dismantlement of stay cable.

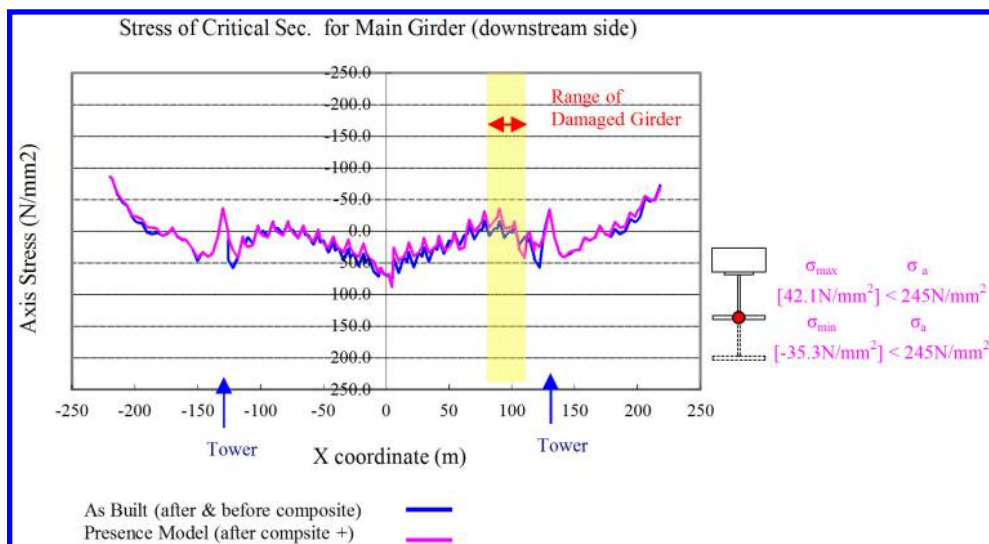
Figure 19. Girder stress after girder damage.

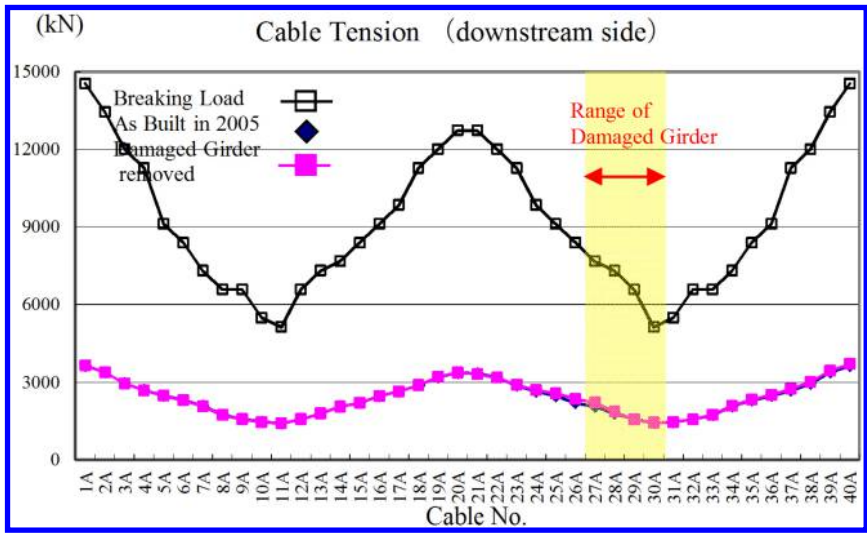
Figure 21. Cable force after removing the damaged girder.

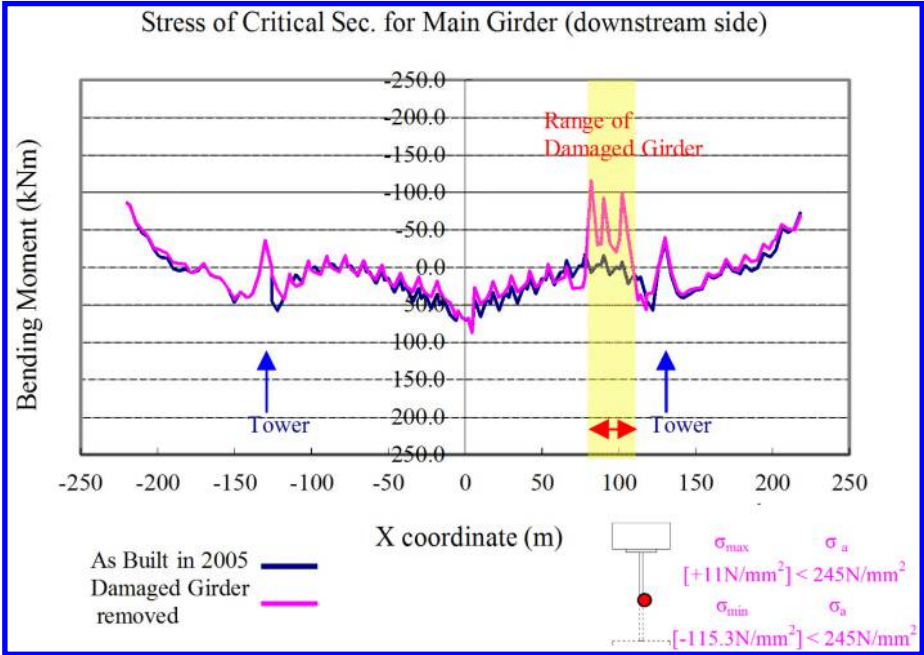
Figure 22. Cable force after removing the damaged girder.

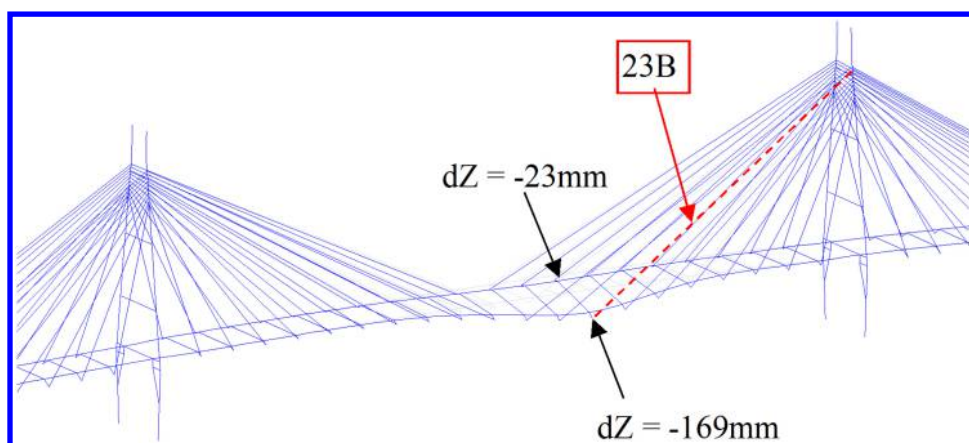
Figure 24. Deflection after removing the damaged stay cable.

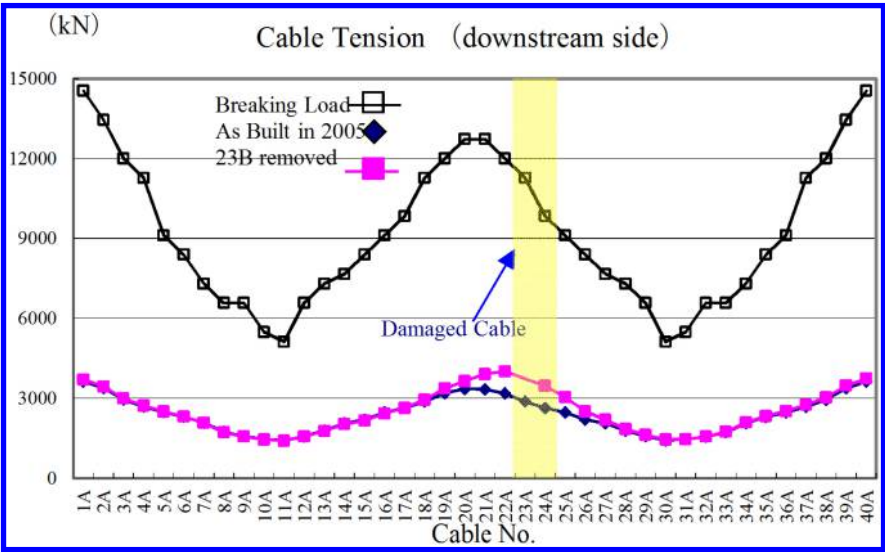
Figure 25. Cable force after removing the damaged stay cable.

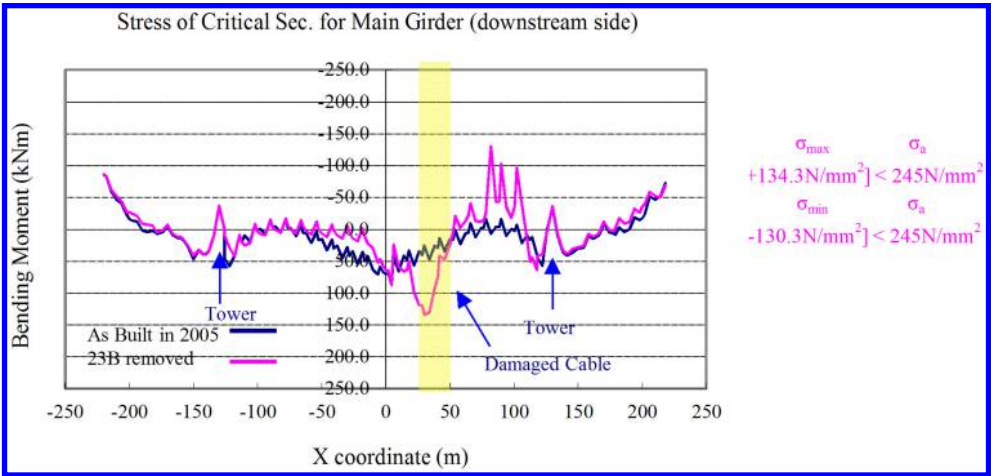
Figure 26. Girder stress after removing the damaged stay cable.

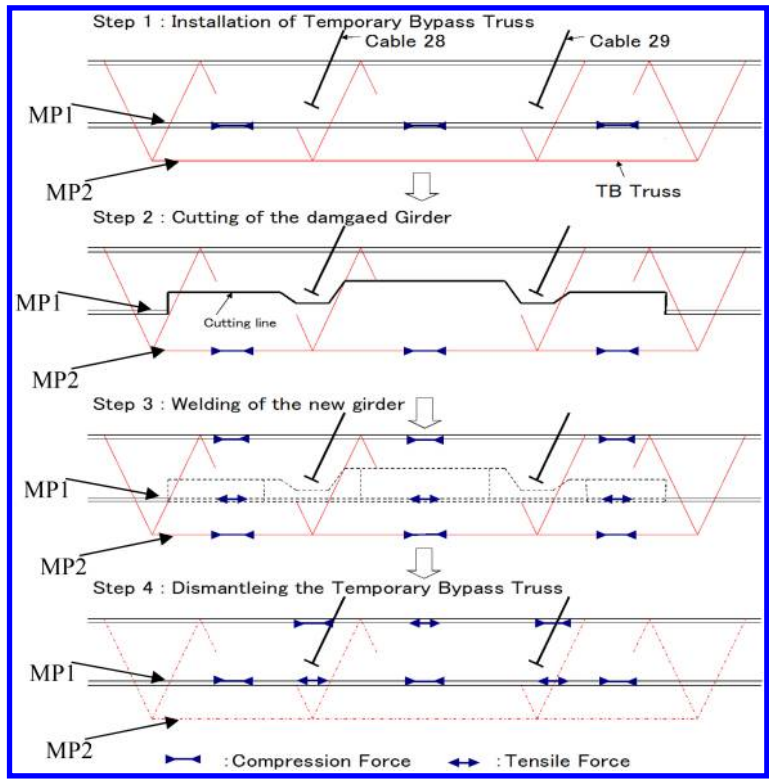
Figure 27. Stress monitoring for each construction step.

From the above result, we concluded that because Temporary Bypass Truss was transferred from the compression force acted on damaged edge girder, it is very efficient for this repair work.

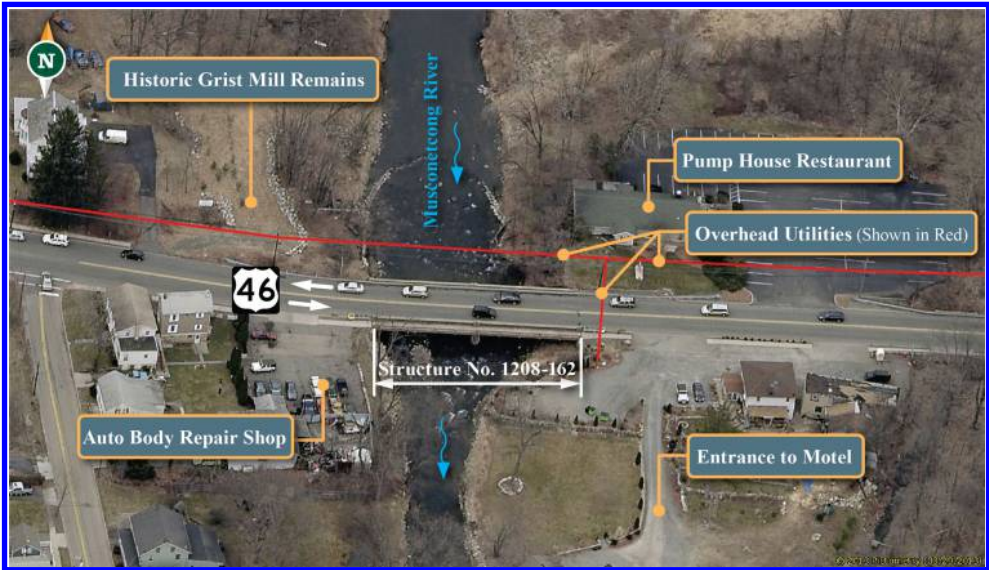
Figure 1. Plan view of the Route 46 over Musconetcong River Bridge.

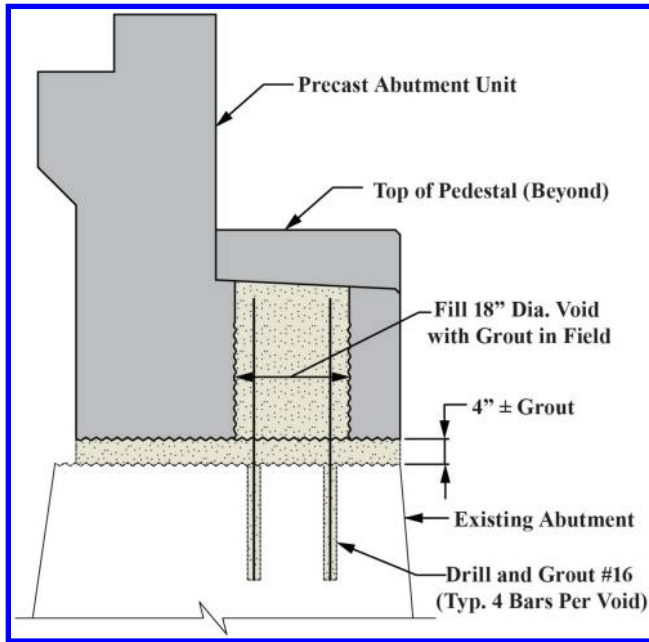
Figure 9. Precast abutment unit connection detail (pier similar).

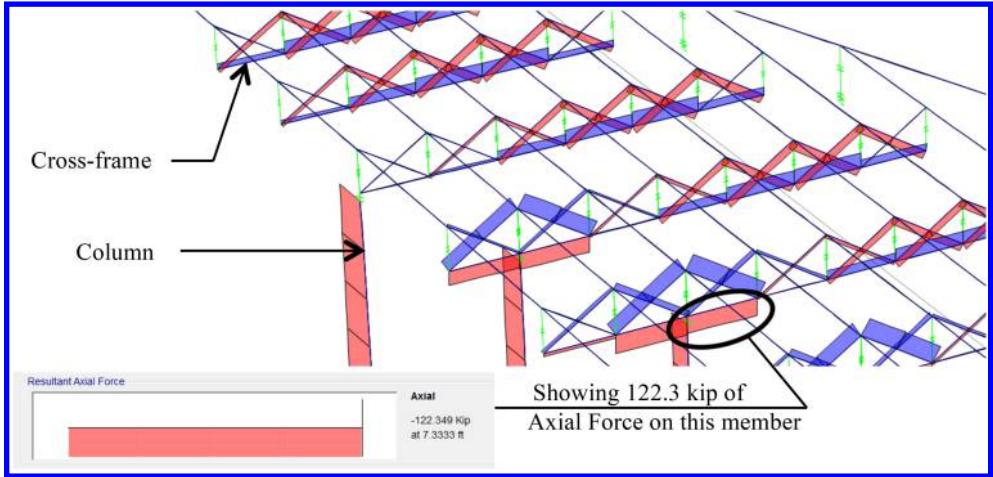
Figure 6. Force contour in a 3D model showing axial forces in cross-frames and columns.

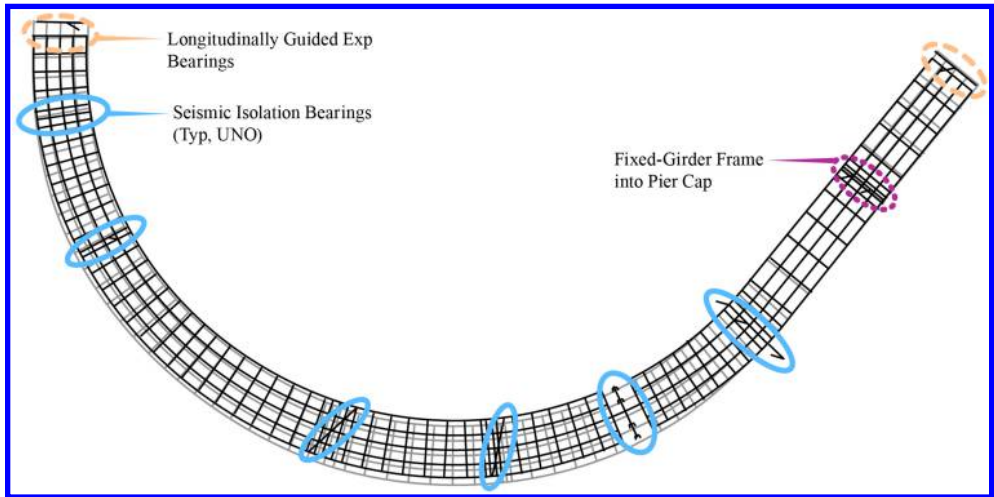
Figure 10. Thermal deformed shape and bearing layout of a severely curved framing – where lighter lines show the original shape, as darker lines show the deformed shape under a 100°F temperature drop.

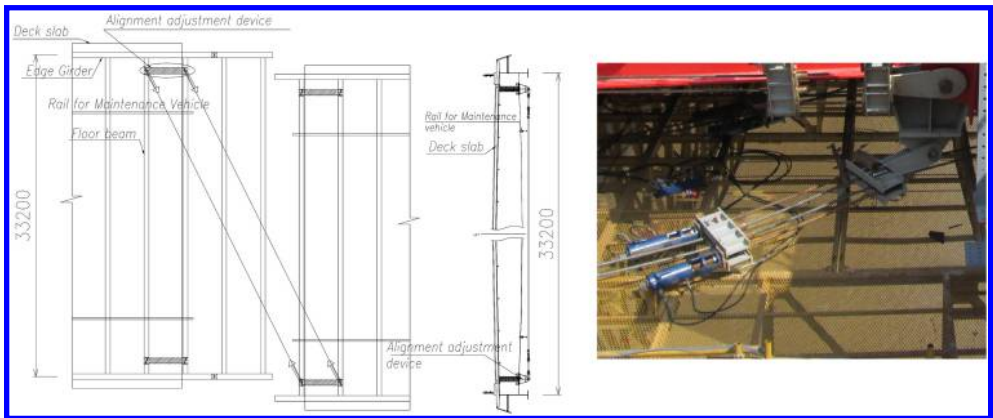
Figure 13. Alignment adjustment device.

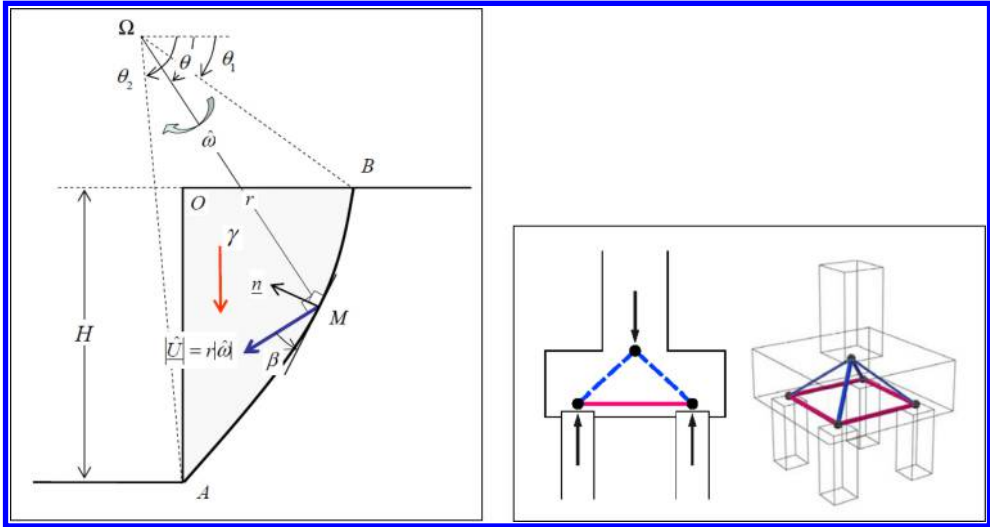
Figure 1. Limit analysis examples. Left: collapse of the rigid block OAB under its weight with AB a logarithmic spiral. Refer to de Buhan (2007). Right: strut-and-tie pattern of a massive reinforced concrete piece. Refer to Gao (2012).

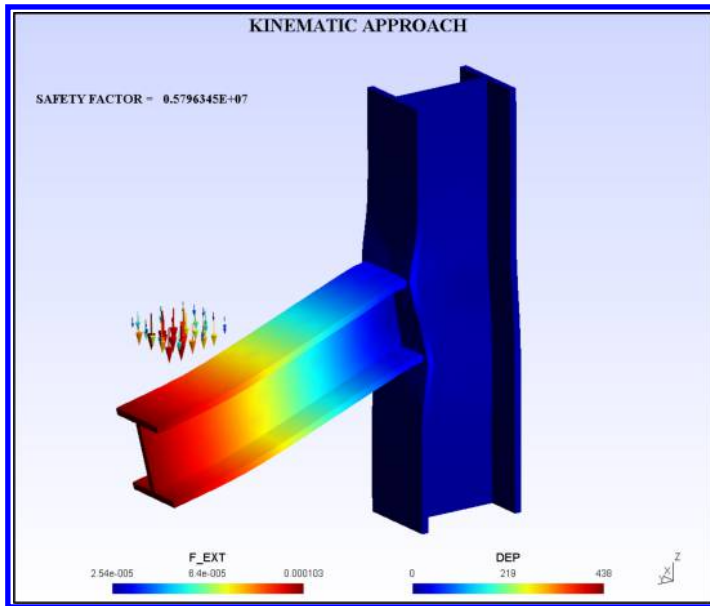
Figure 4. Kinematic approach output: failure mechanism and safety factor upper bound.

Both approaches combined provides full knowledge mechanism behavior: stress distribution, displacements field and the bounds of the safety factor (Figure 4).

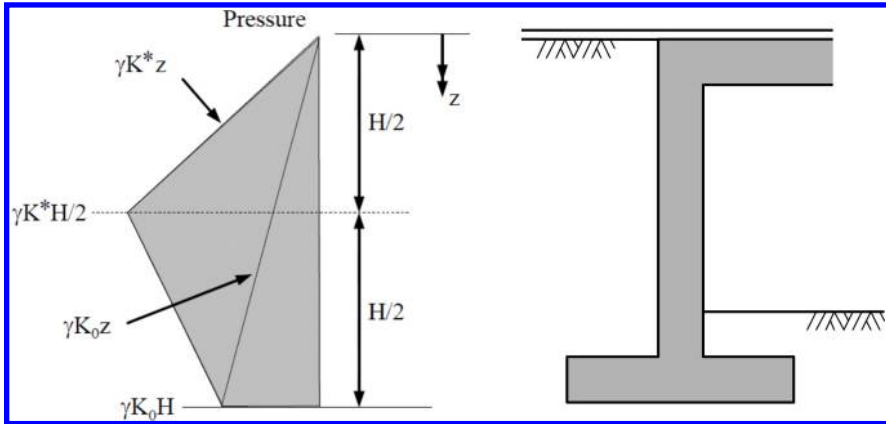
Figure 2. Assumed earth pressure distribution for full height abutment on flexible foundations after PD6694-1 (BSI 2011) Fig 5.

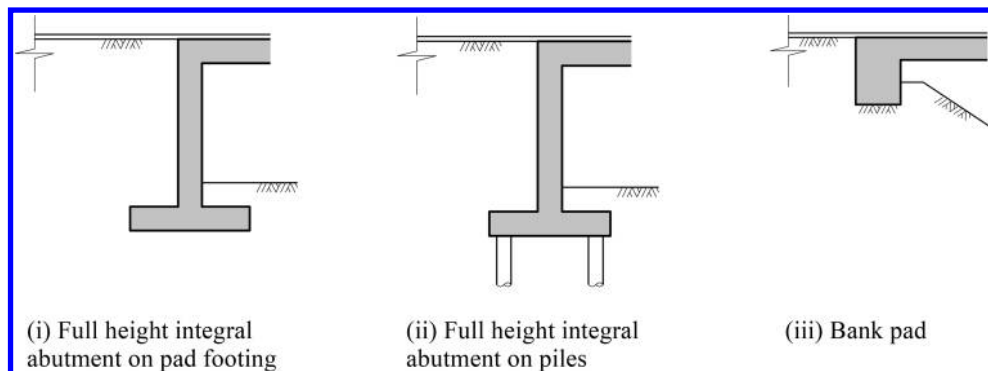
Figure 4. Integral abutment types which can typically be designed with K^* approaches.

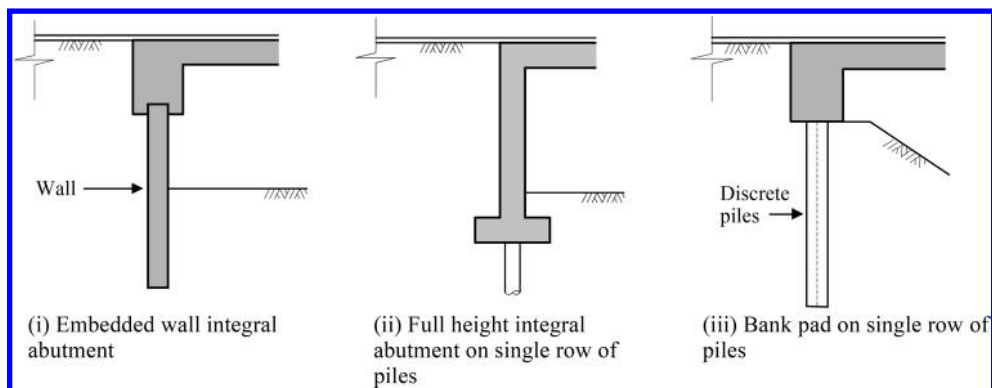
Figure 6. Integral abutment types which typically require SSI analysis.

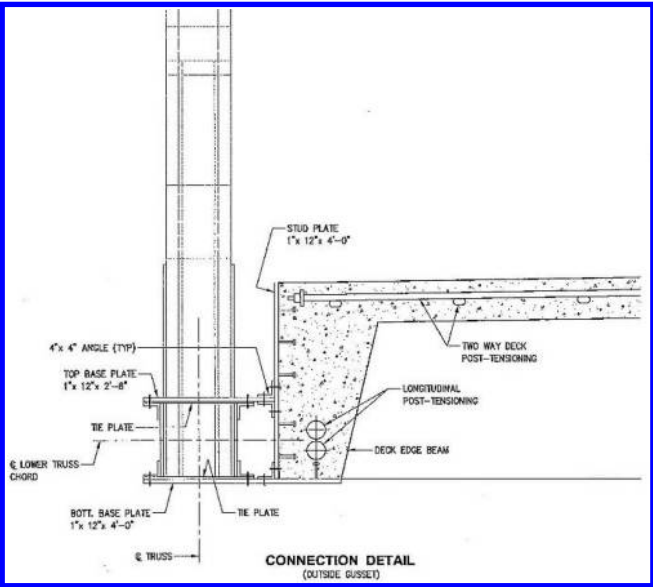
Figure 10. Connection details.

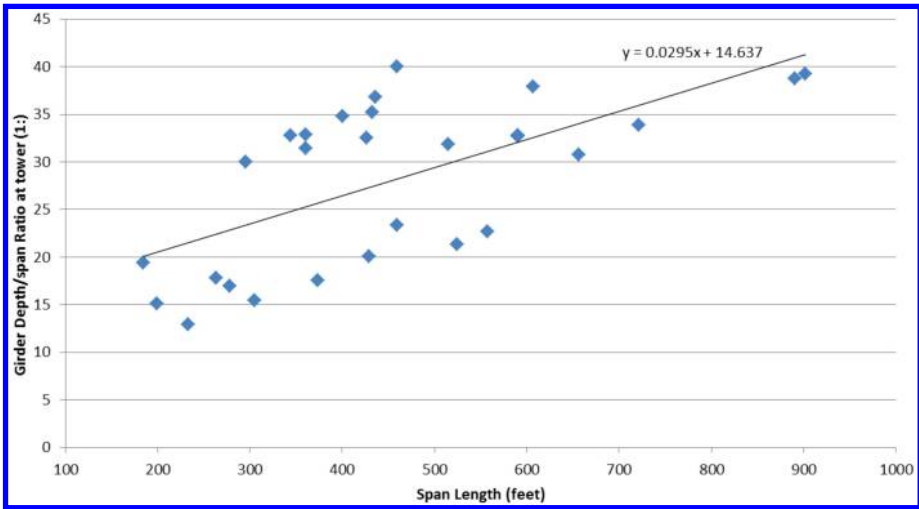
Figure 7. Girder depth/span length comparison for full range of extradosed bridges.

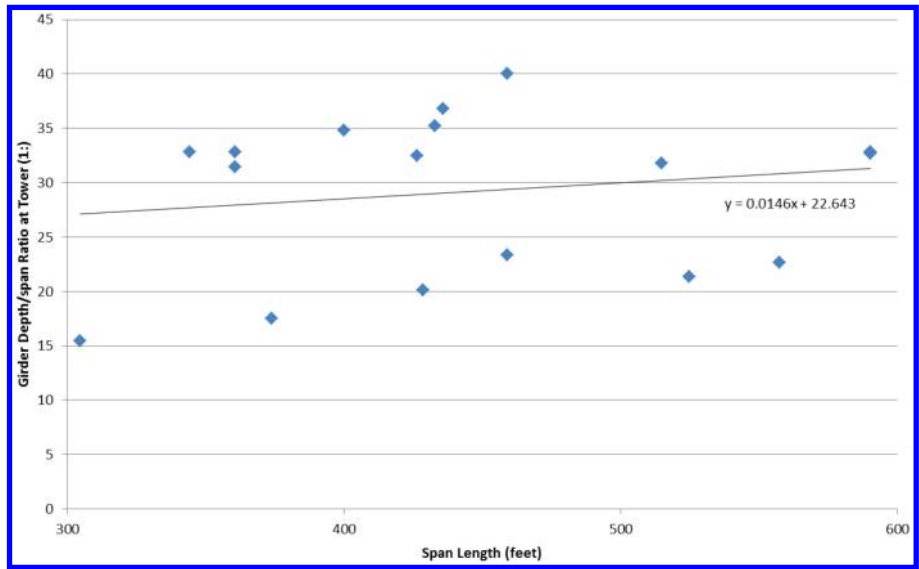
Figure 8. Girder depth/span length comparison for 300–600 ft. span range of extradosed bridges.

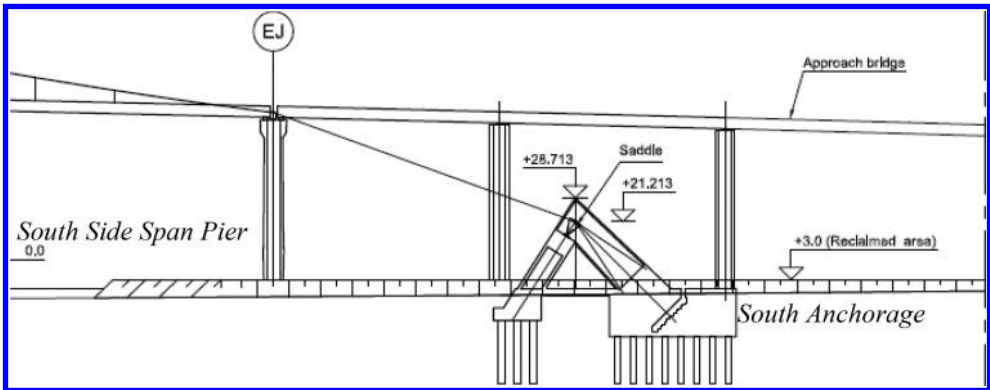
Figure 4. The South Anchorage Structures during the tender design.

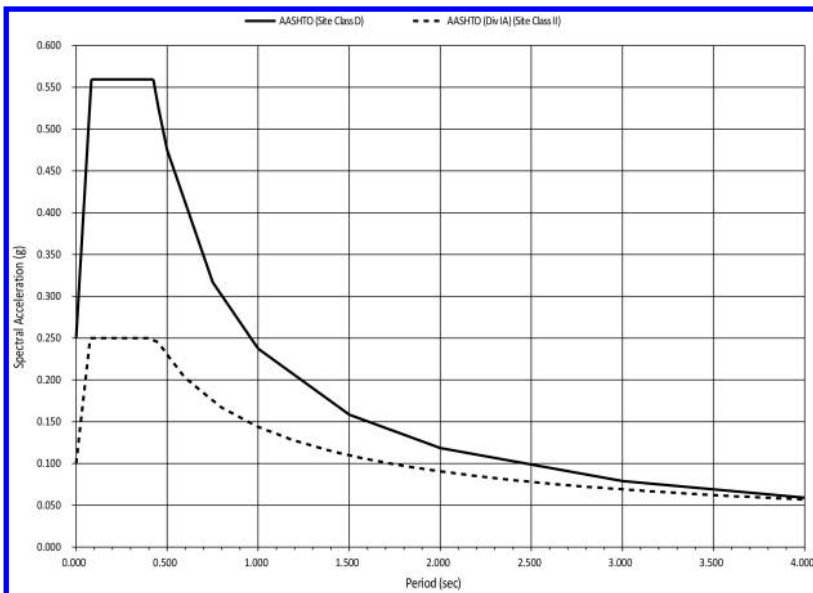
Figure 5. Acceleration response spectrum based on AASHTO general procedure. Retrofit spectrum (AASHTO Div. IA) is shown for comparison.

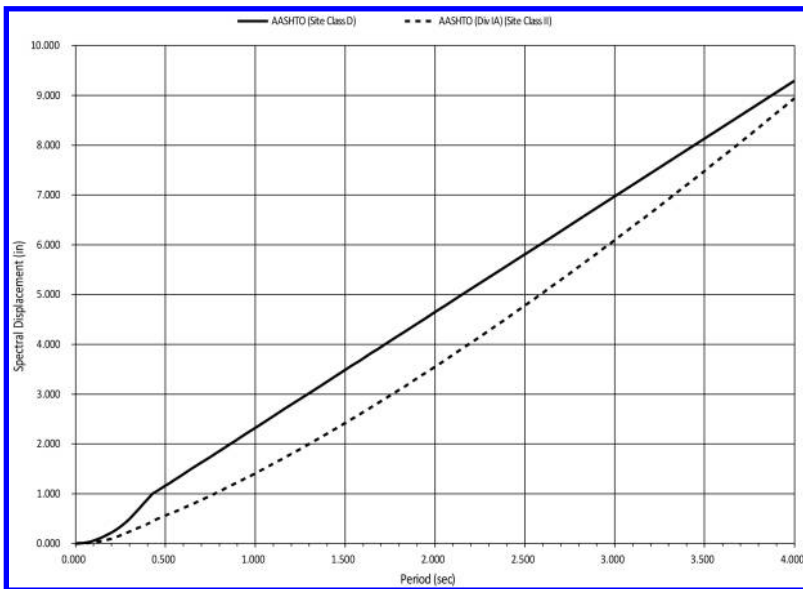
Figure 6. Displacement response spectrum based on AASHTO general procedure. Retrofit spectrum (AASHTO Div. IA) is shown for comparison.

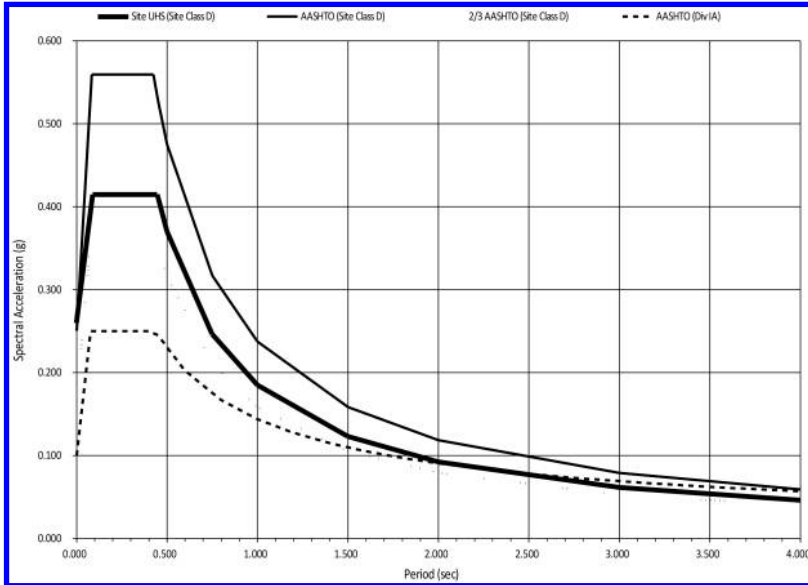
Figure 7. Site specific acceleration spectrum for Site Class D compared with Guide Spec and Standard Spec Spectra.

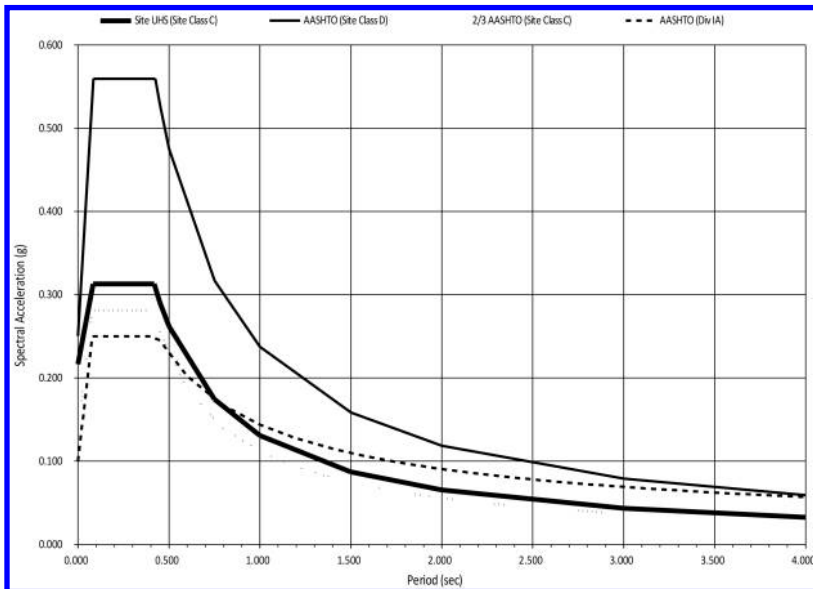
Figure 9. Site specific acceleration spectrum for Site Class C compared with Guide Spec (Site Class D) and Standard Spec Spectra.

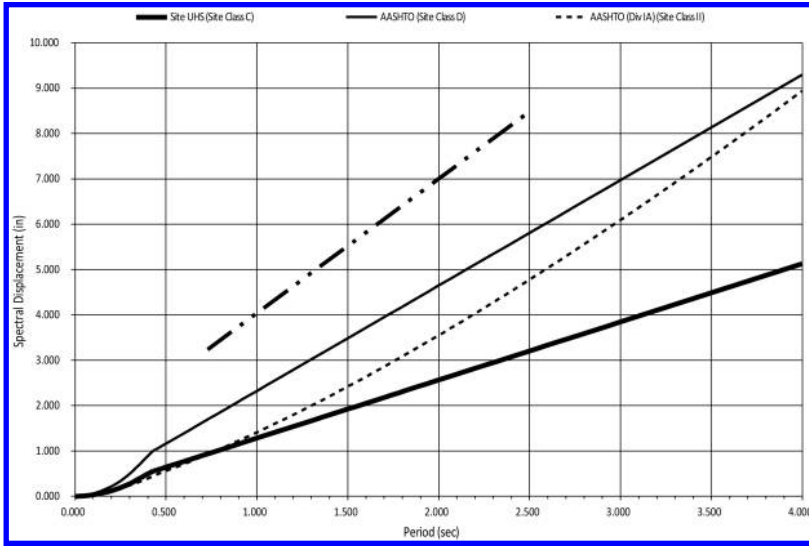
Figure 10. Site specific displacement spectrum for Site Class C compared with Guide Spec (Site Class D) and Standard Spec spectra. The heavy dashed at the top shows the lower bound displacement capacity of the existing bents for the expected range of natural periods within which the existing structure would respond.

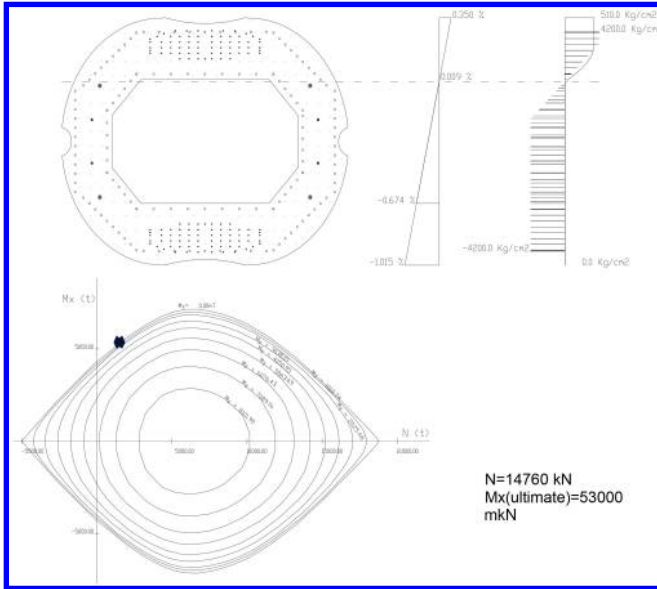
Figure 7. N-M interaction diagram of a cross section of the pier.

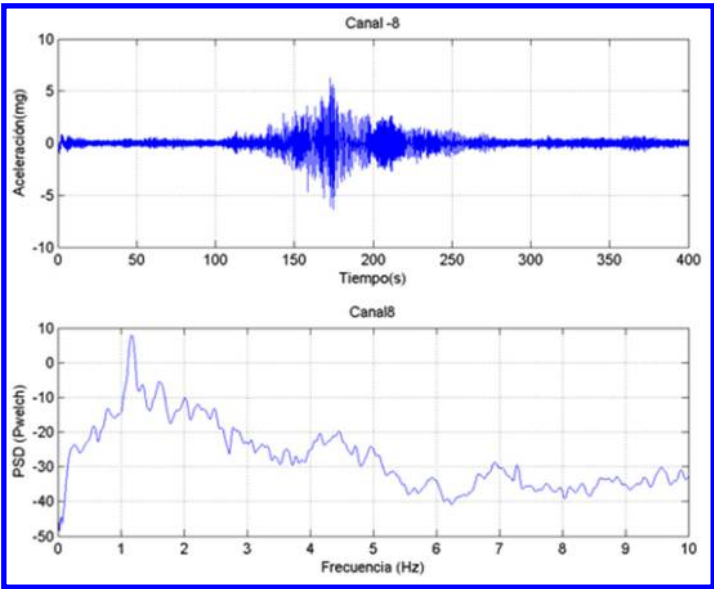
Figure 10. July/29/2014 earthquake. Horizontal acceleration and frequency dependant response.

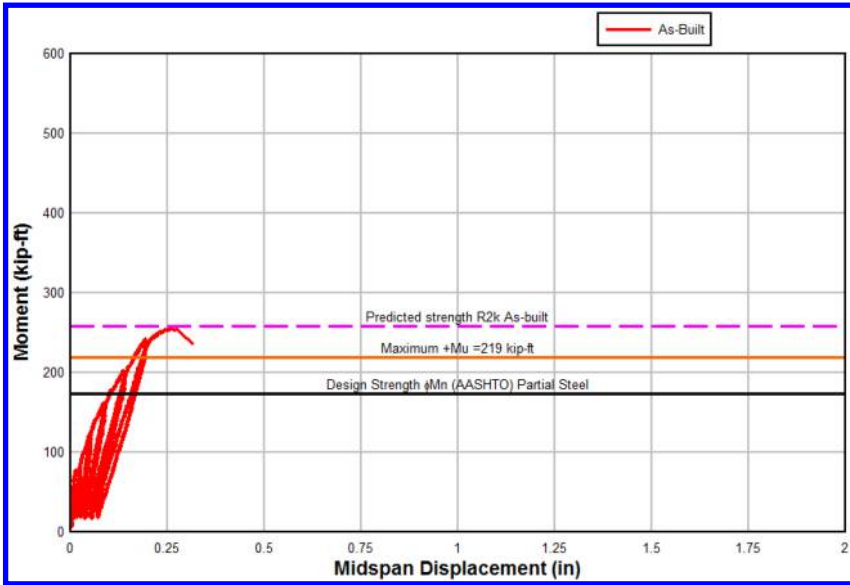
Figure 7. Mosier 1 predicted capacity and demand shown with experimental response.

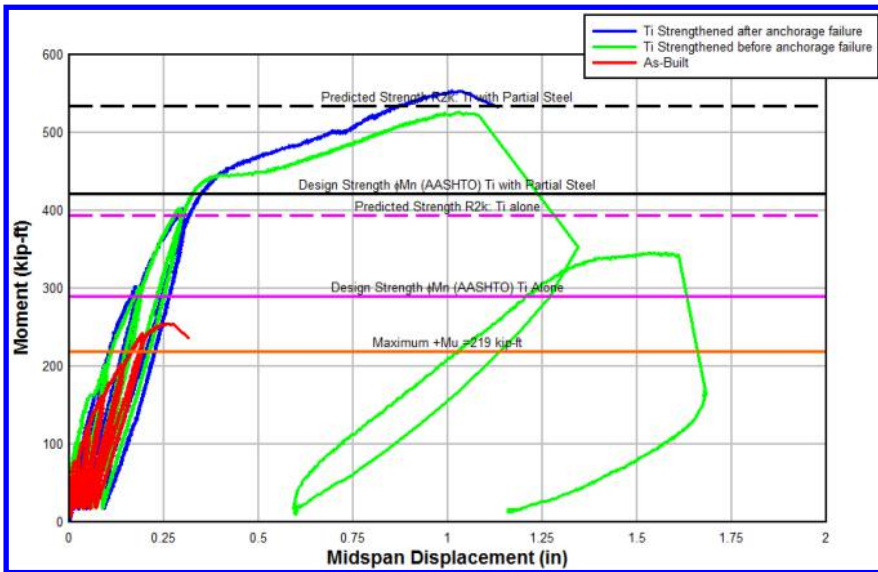
Figure 8. All Mosier specimens with predicted capacity and demand shown with experimental responses.

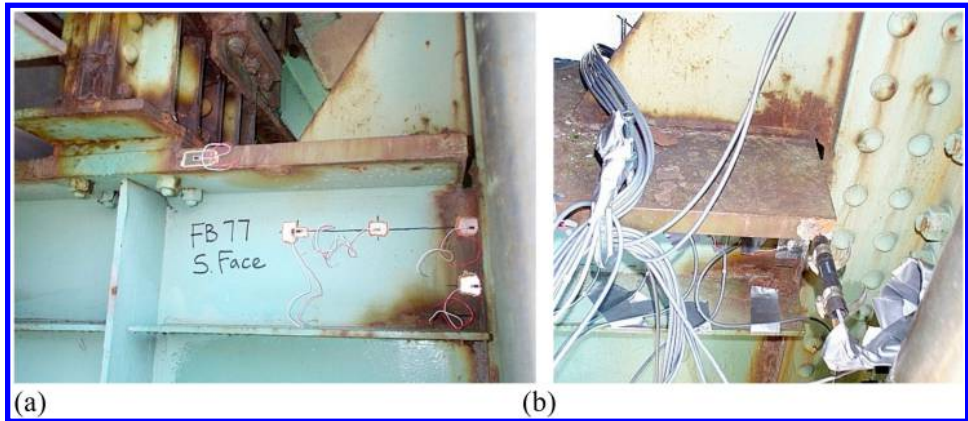
Figure 5. Pre-retrofit instrumentation on lower deck FB 77 (PP 13): (a) strain gages on web (same positions on each face); (b) displacement transducer for out-of-plane movement.

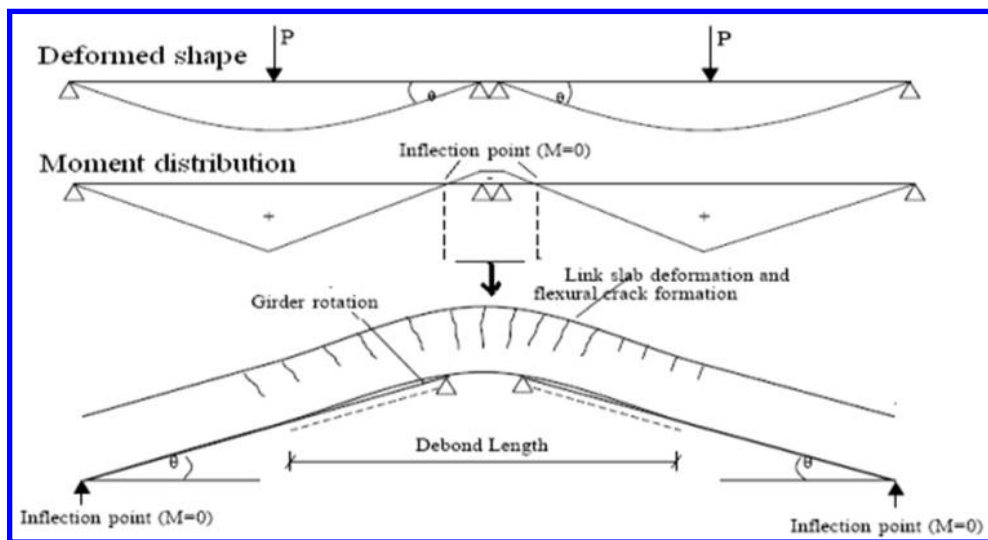
Figure 3. Two span bridge deformation with focus on link slab section (Kim et al. 2004).
