Sustainable Bridge Structures

Edited by Khaled M. Mahmoud

Khaled M. Mahmoud

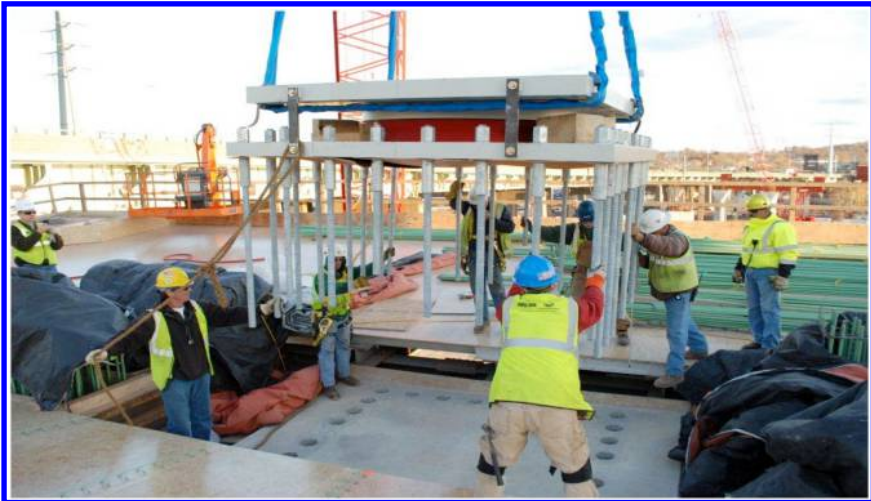
Figure 12. Disktron bearing installation at the Q Bridge.

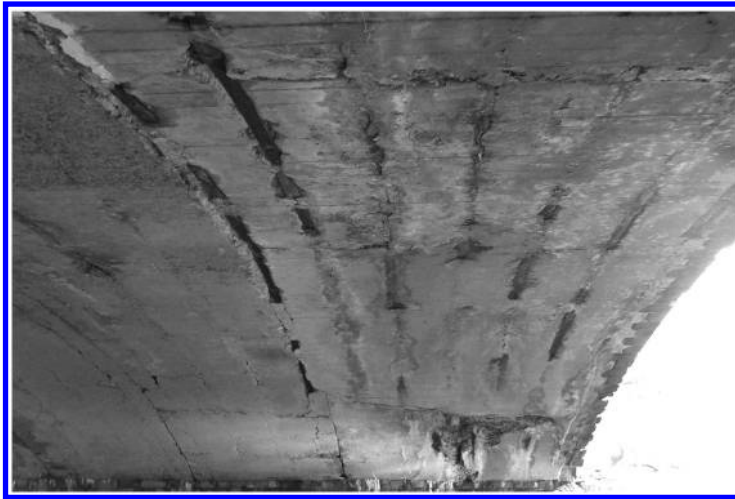
Figure 5. Existing Condition – Arch Intrados, 2000.

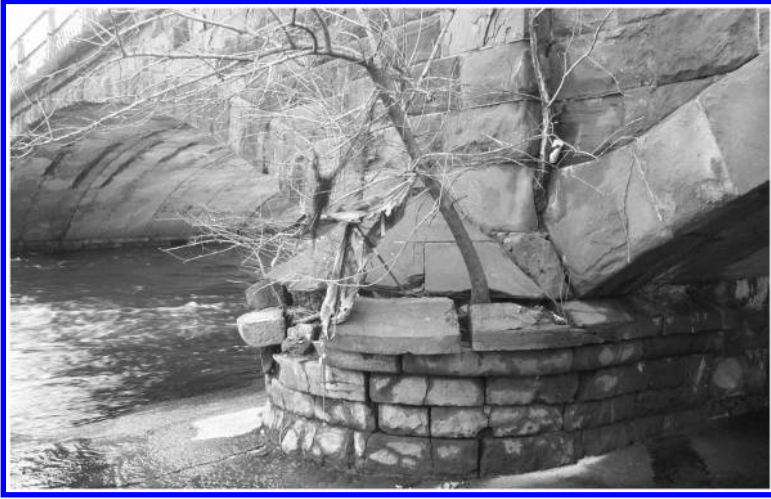
Figure 6. Existing Condition – Pier Nose, 2000.

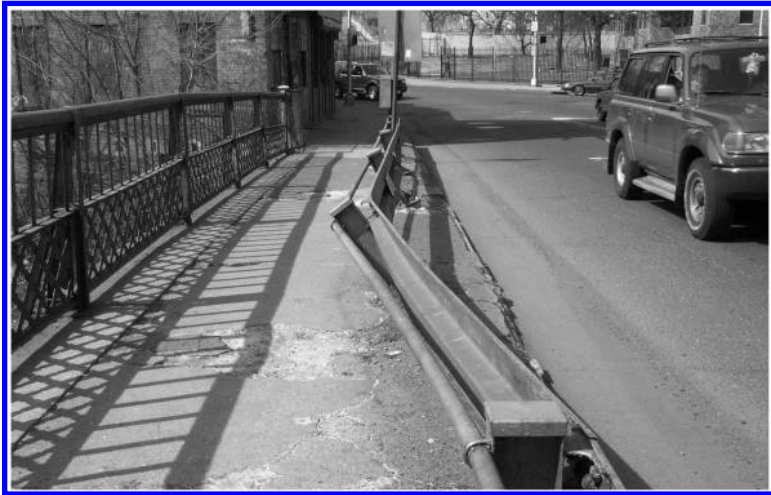
Figure 7. Existing Condition – Railing Safety Features, 2000.

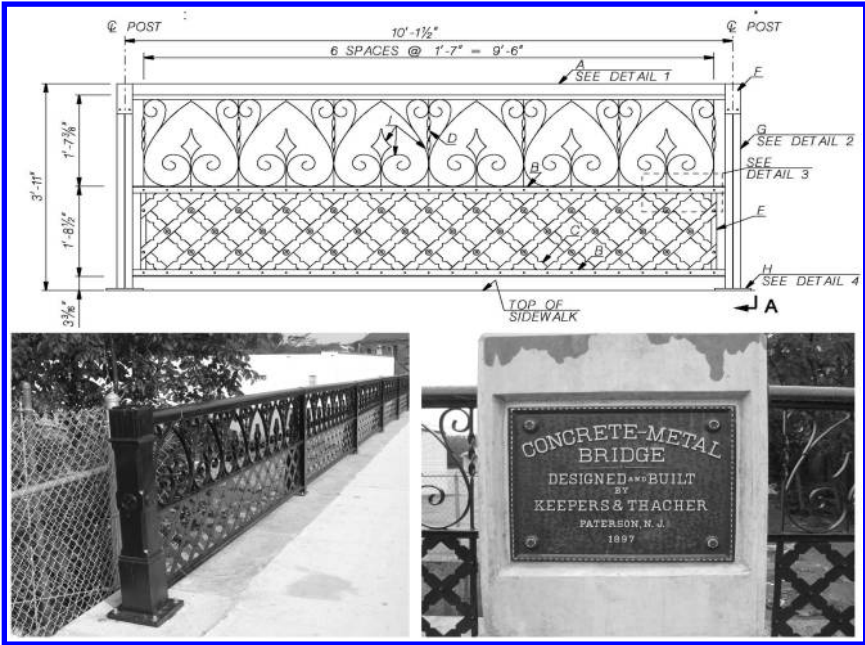
Figure 12. Pedestrian Railing Panel replicated from 1898 Postcard and Original Bridge Plaque, 2008.
